IMPROVING THE OPERATIONAL CONDITION OF THE AMU-KORAKOL CANAL

Hydrostructure of the Amu-Karakol canal. Launched in 1962. The author of the project is Yu.M.DANILOV.

Some deficiencies were discovered during the field observation work on the Amu-Karakol canal

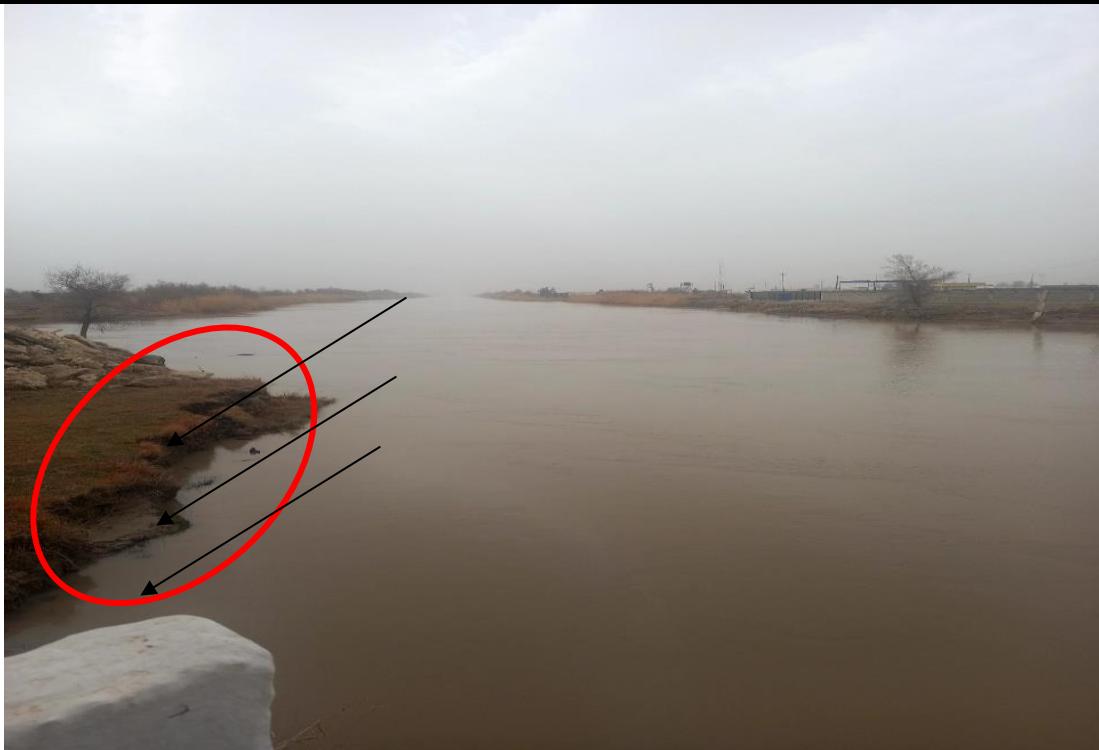
The reinforced concrete side of the structure was sinking. (backfilling) cause should be studied and prevented (inviting ODSP-24, designer and "Kogon water construction" Limited Liability Company managers) and the left and right bank of the structure in the water direction At the same time, the cases of turbidity in the lower part of the river are increasing, and it is necessary to take immediate measures to restore it.

1.1-picture The state of washing of the banks of the building's supply channel

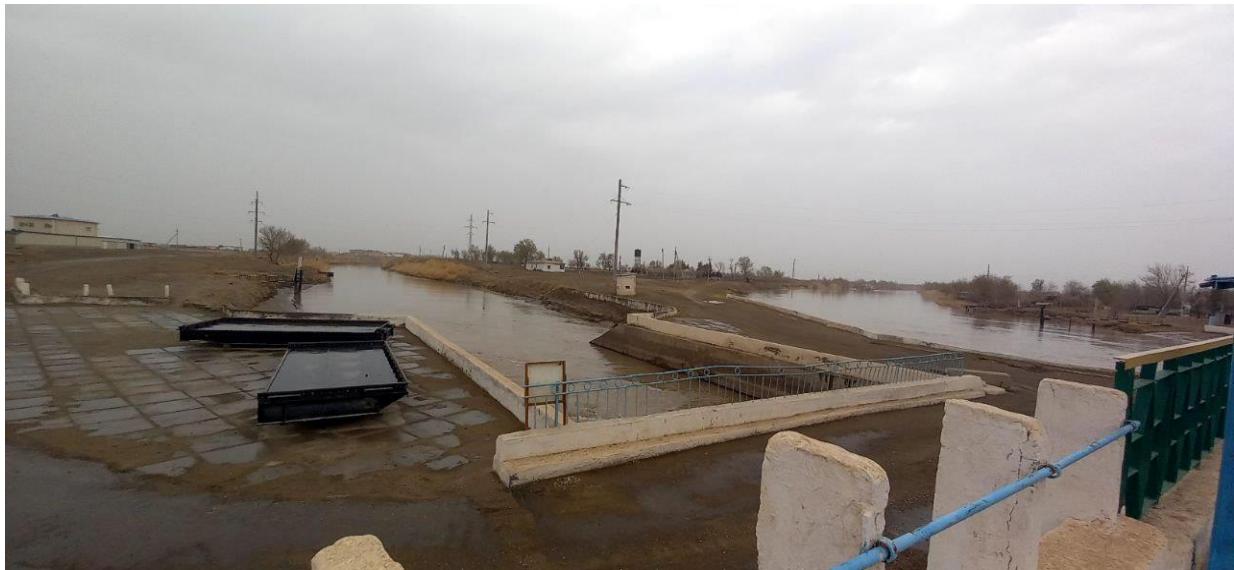
4. Drainage trough: The condition is not up to the standard, there are cracks in the concrete part on the left and right slopes, it should be prevented as soon as possible.

1.2- picture The condition of the Amu-Karakol drainage basin

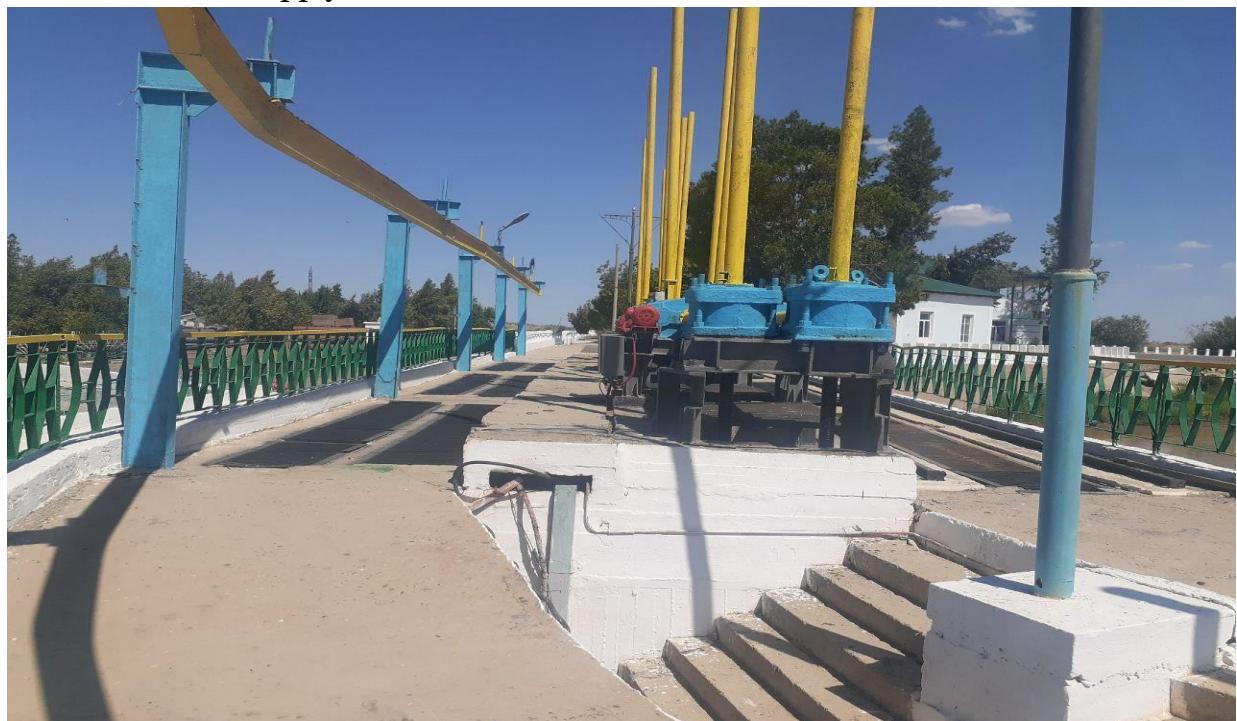
7. Power supply: 170 kVa transformer, 400 kVa transformer does not have additional diesel supply.

1.3-Fig. Status of electric divergatels

7.	The electrical supply system of the facility should be re-examined before the season.	In order to ensure the technical condition and safety of the facility

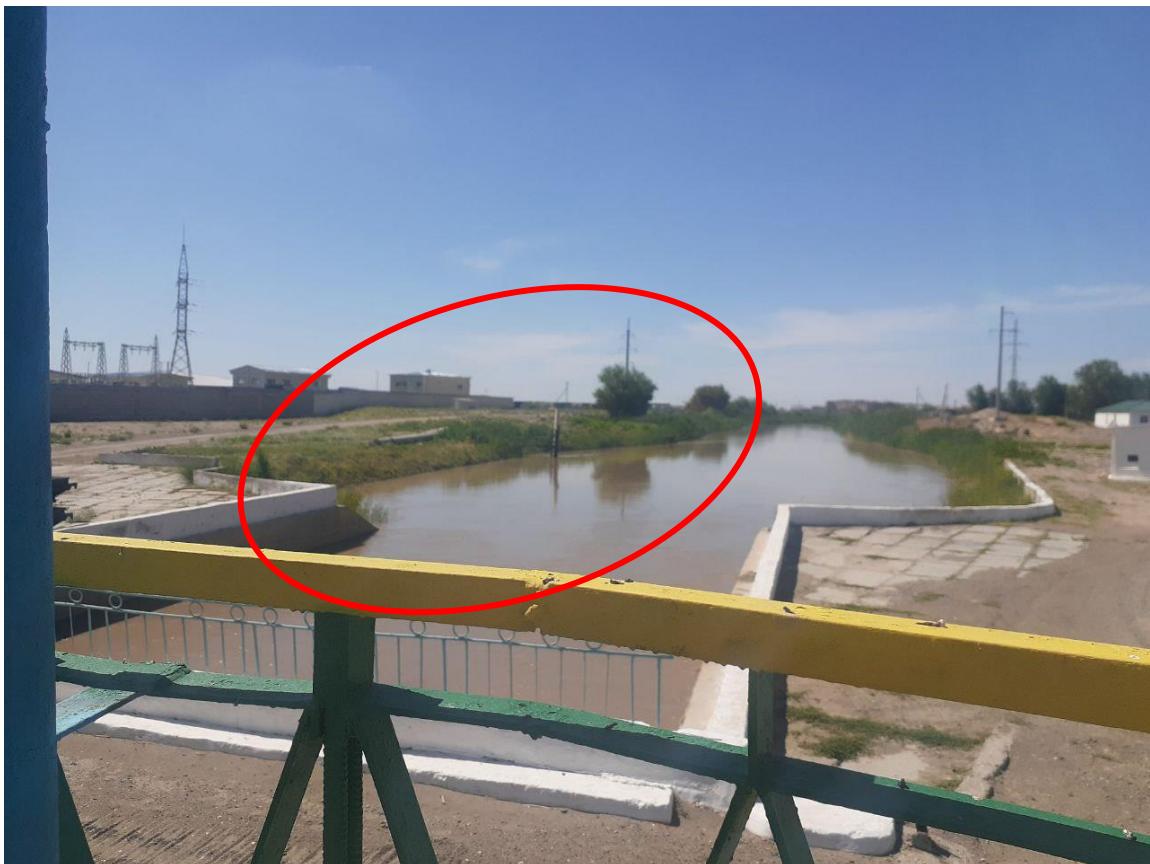
12. In the water-carrying river - a part of the river is covered with plants (mainly reeds) and mud, washing occurred on the right bank, the coating of the right bank dam is eroded, the water discharge facility no stone has been spilled in the water impact well,

the shutters are corroded, the mechanical equipment of the shutters is not up to standard.

1.4- picture The condition of the water-carrying core of the hydrogel Requirements to be met for reliable and safe use of the Amu-Karakol canal hydroelectric unit.
